Indoor Coil Corrosion Industry Research Report

Introduction

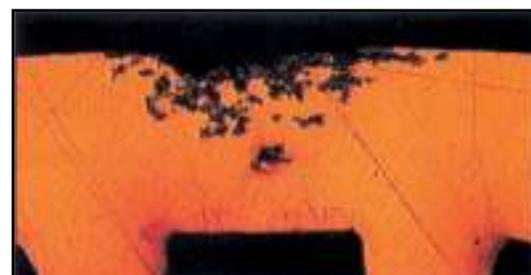
Fig. 2 Formicary Corrosion Tunneling

Formicary corrosion, on the other hand, appears as multiple tiny pinhole leaks at the surface of the copper tube that are not visible to the human eye. Upon microscopic examination, the formicary corrosion pits show networks of interconnecting tunnels through the copper wall, hence the association with ants’ nests. The agents of attack involved in this corrosion mechanism are organic acids.
